AA-339
 Radoff House, aka Goshen
 Plan View, First Floor

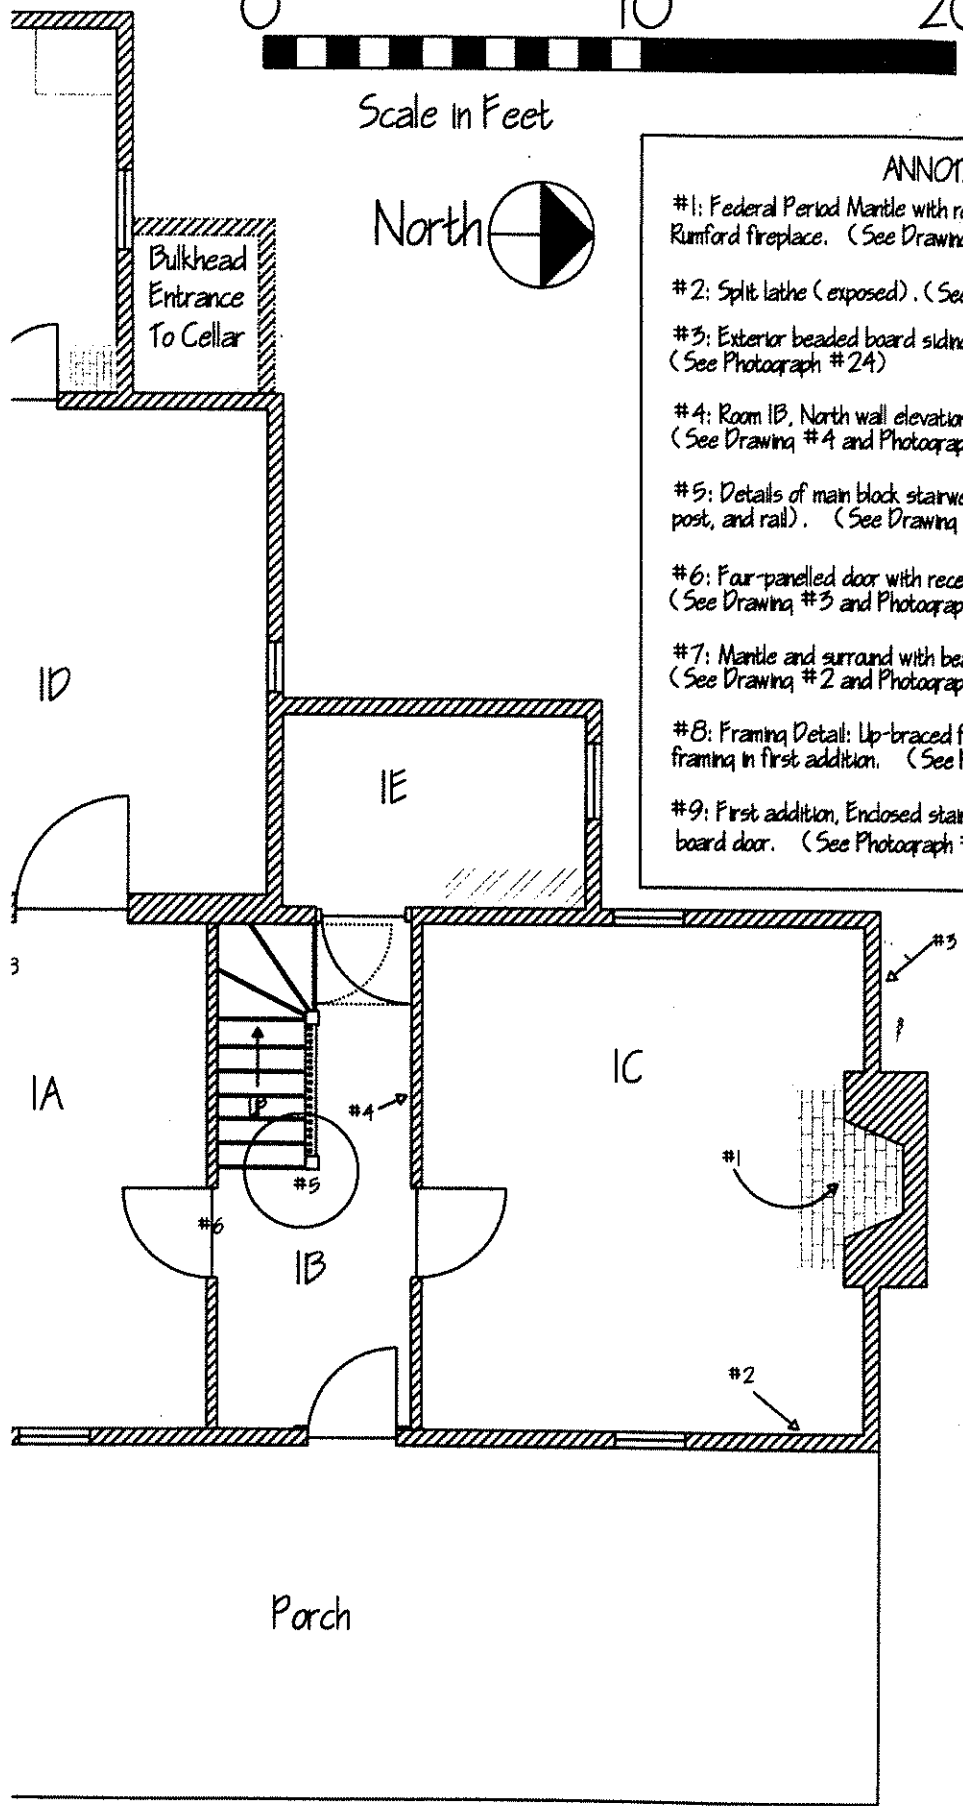
- ANNOTATIONS**
- #1: Federal Period Mantle with reverse ogee & bead molding, Rumford fireplace. (See Drawing #1 and Photographs #21 & #22)
 - #2: Split lathe (exposed). (See Photograph #23)

- #3: Exterior beaded board siding (Visible from interior hole in wall) (See Photograph #24)
 - #4: Room 1B, North wall elevation, showing beaded panel wall. (See Drawing #4 and Photographs #15 & #16)

- #7: Mantle and surround with beaded molding; Rumford fireplace (See Drawing #2 and Photograph #11)
 - #8: Framing Detail: Up-braced framing in Main Block, with balloon framing in first addition. (See Photograph #13)

- #9: First addition, Enclosed stairwell (to second floor) with beaded board door. (See Photograph #35)

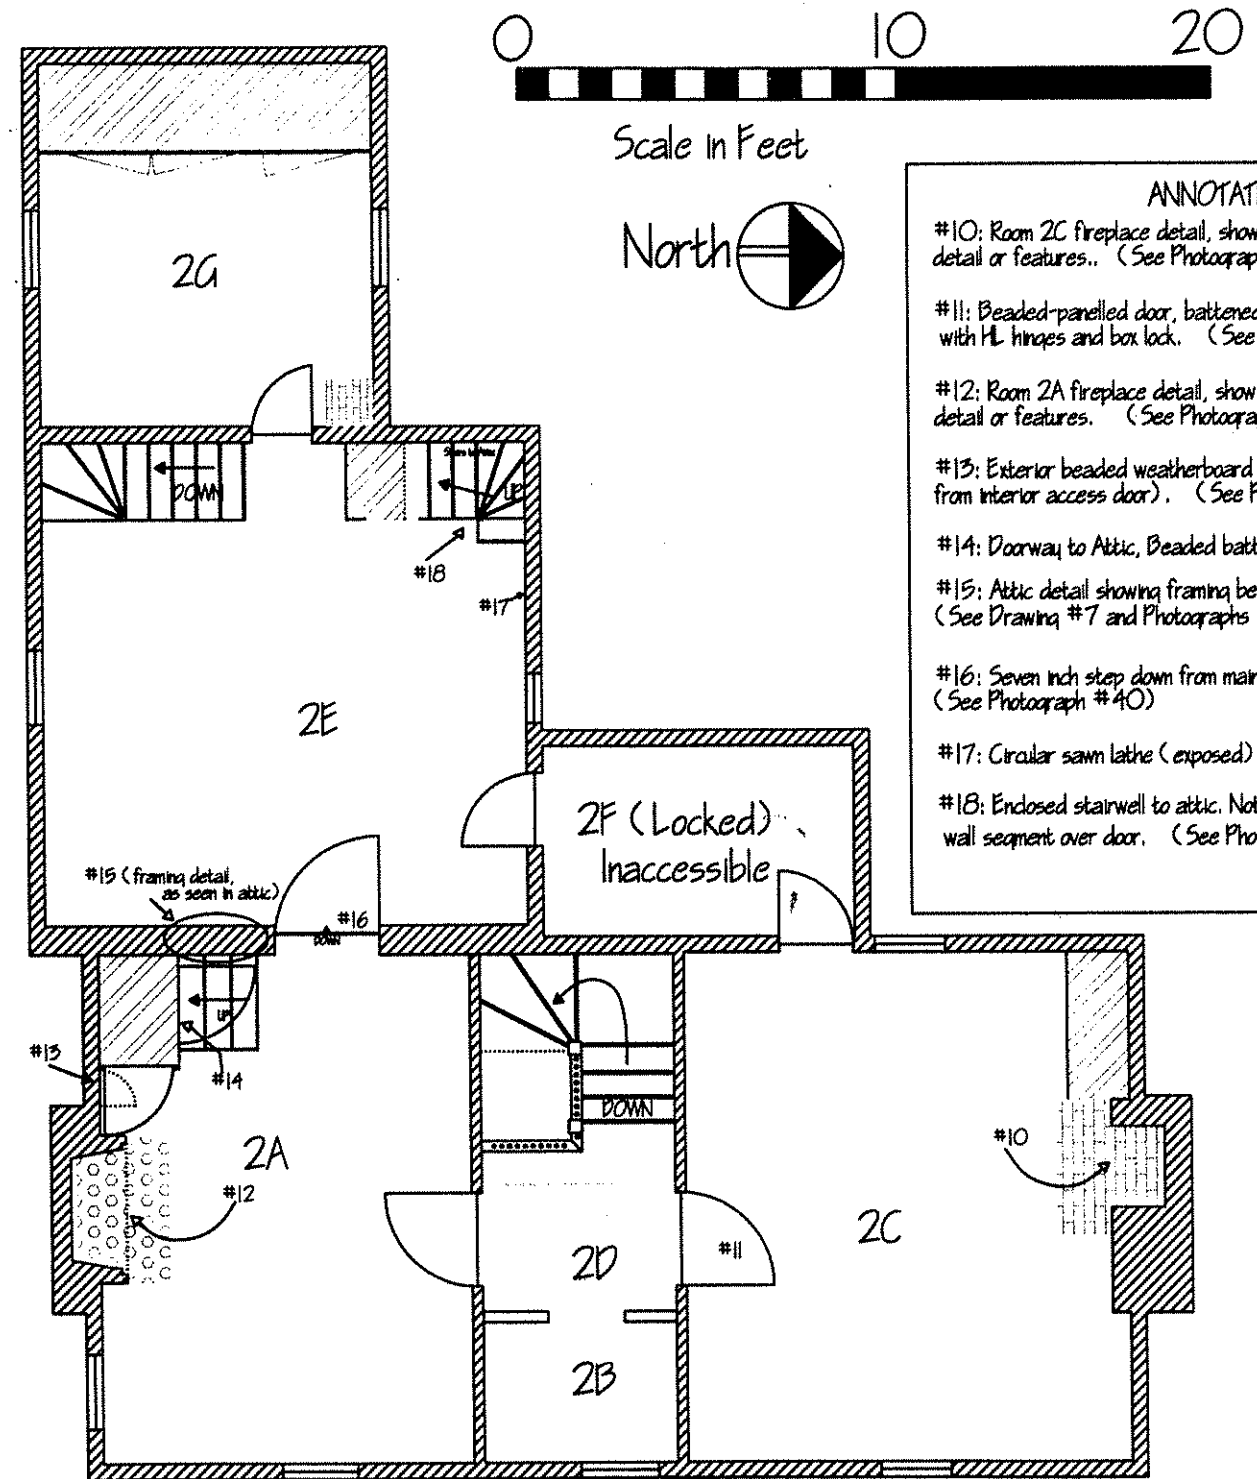
- ANNOTATIONS**
- #10: Room 2C fireplace detail, showing lack of mantle, decorative detail or features.. (See Photograph #27)
 - #11: Beaded-panelled door, battened on the interior of room 2C, with HL hinges and box lock. (See Drawing #6)

- #12: Room 2A fireplace detail, showing lack of mantle, decorative detail or features. (See Photograph #28)
 - #13: Exterior beaded weatherboard siding and brace framing (visib from interior access door). (See Photograph #29)
